NBSIR 84-2810

January 1984

**PERFORMANCE EVALUATION OF
TELEPHONE CABLE PEDESTALS IN
UNDERGROUND AND ATMOSPHERIC
ENVIRONMENTS**

J. L. Fink and E. Escalante

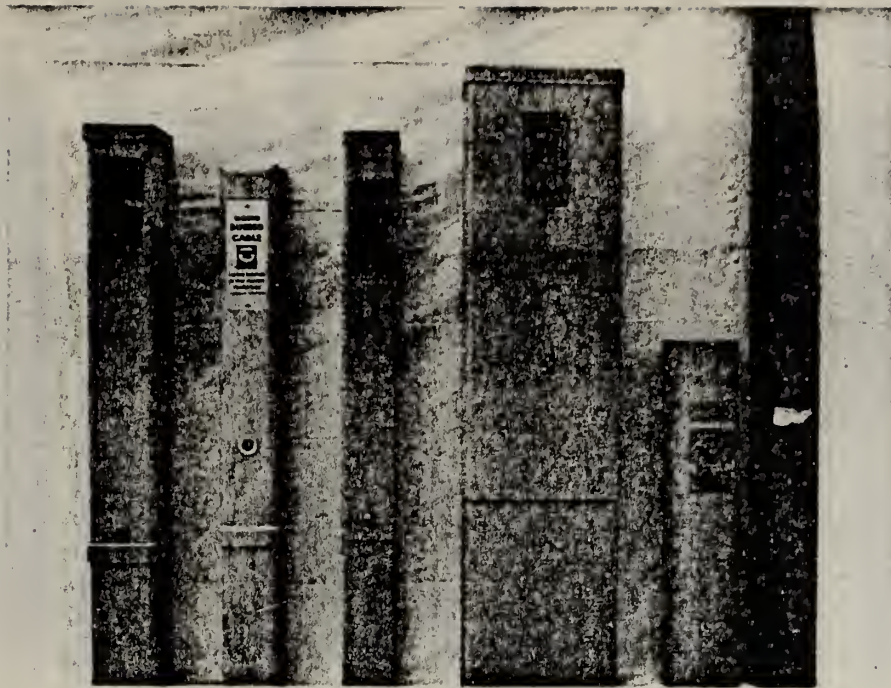
Figure 4. Systems 1,2,3,4,and 5, left to right. These pedestal specimens were considered unaffected by corrosion and/or degradation after exposure for one year at Site A.

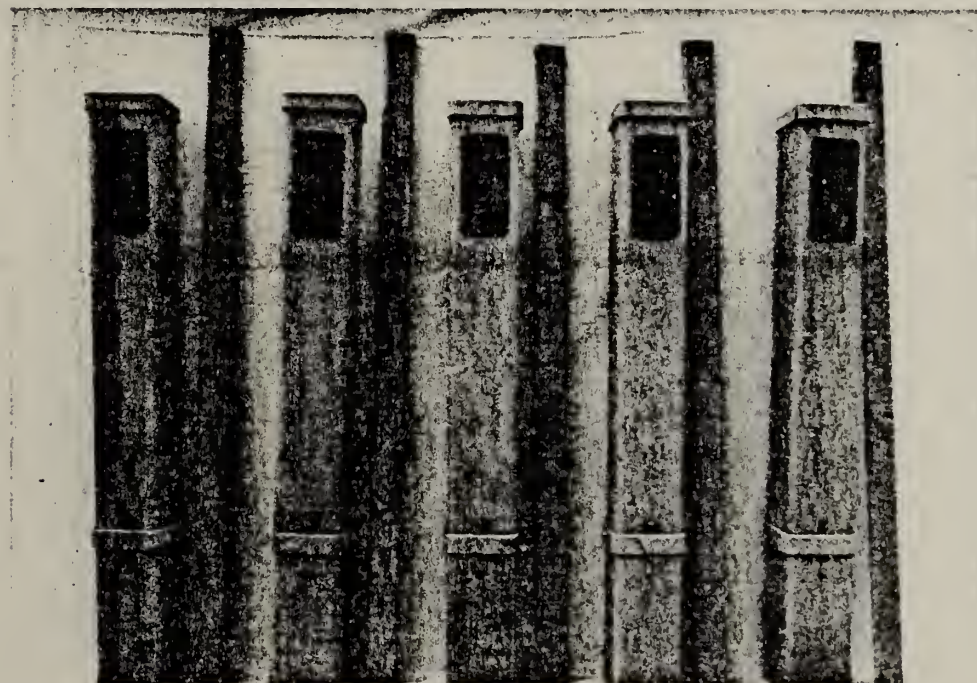
There was no degradation of the fiberglass surface on specimens of this system exposed for one year at Sites A, C, G, and H and for three years at Site B. The specimens exposed at Sites H and I for six years indicated slight degradation on the outside of the fiberglass cover plate. Slight to moderate degradation on the outside of the fiberglass cover plate cap was noted on the specimens exposed at Sites B, C, G, H, and I for six years. The specimens exposed at Sites B, H, and I for six years showed slight degradation of the fiberglass surface on the outside of the back plate above ground level. Slight cracking on the outside of the back plate above ground level was noted on the specimens at all sites exposed for six years.

Figure 5. System 1, Sites B,C,G,H, and I, left to right, exposed for six years. Moderate degradation of the fiberglass surface on the cover plate was observed on all specimens.

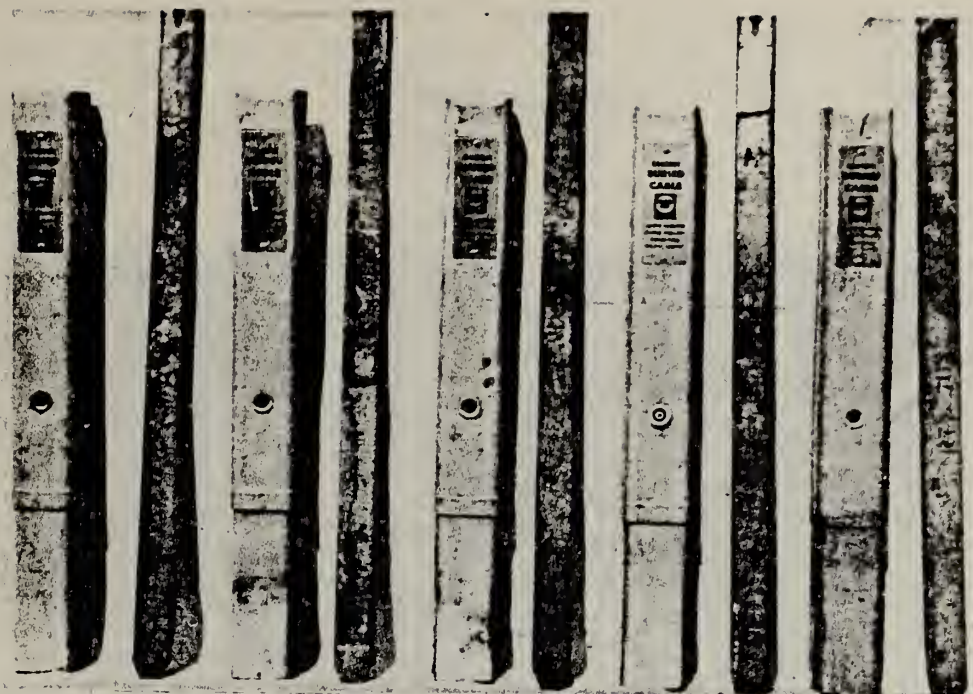
The pedestals exposed for one year at Sites A, B, G, and H showed little or no degradation of the fiberglass surface. Varying degrees of degradation were noted on the outside of the fiberglass cover plate, cover plate cap, and the back plate above ground level of specimens exposed for two, three, four and six years at Sites B, C and G. However, the most severe degradation was observed on the same regions after exposure for six years at Site H and on the cover plate and cover plate cap after exposure for six years at Site I.

The unpainted galvanized steel mounting stake showed little or no corrosion after exposure for six years at Sites H and I. Slight attack was observed on the galvanized steel surface of the mounting stake below ground level after six years of exposure at Site B, while slight dissipation and pitting was noted on the mounting stake after exposure for six years at Site C. Pitting due to corrosion of 0.001 in. to 0.005 in. and rust stain was found on the mounting stake below ground level after six years of exposure at Site G.

Figure 6. System 2, Sites B,C,G,H, and I, left to right, exposed for six years. Moderate to severe degradation of the fiberglass surface on the cover plate, cover plate cap, and back plate above ground level on specimens at Sites B,C,H, and I. Dark areas indicate corrosion of the mounting stakes at Sites C and G.

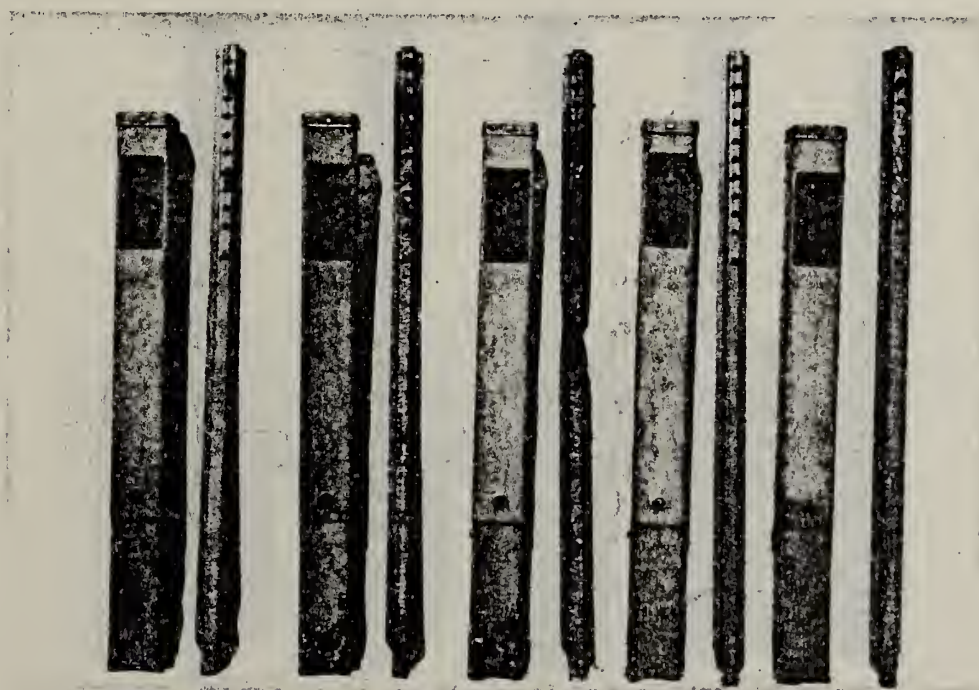
Figure 7. System 3, Sites B,C,G,H, and I, left to right, exposed for six years. Dark areas on specimens indicate corrosion on the mounting stake at Site C and the ground cover plate below ground level at Site G. Severe corrosion of the mounting stake below ground level on the specimen at Site G.

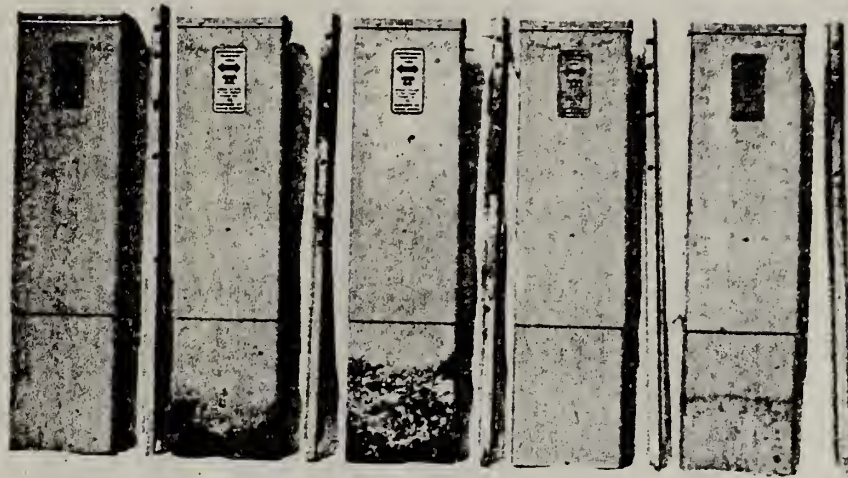
Figure 8. System 4, Sites B,C,G,H, and I, left to right, exposed for six years. Dark areas indicate corrosion on the mounting stake and ground cover plate below ground level of the specimen at Site G. The warning sign on the specimen at Site I was not legible.

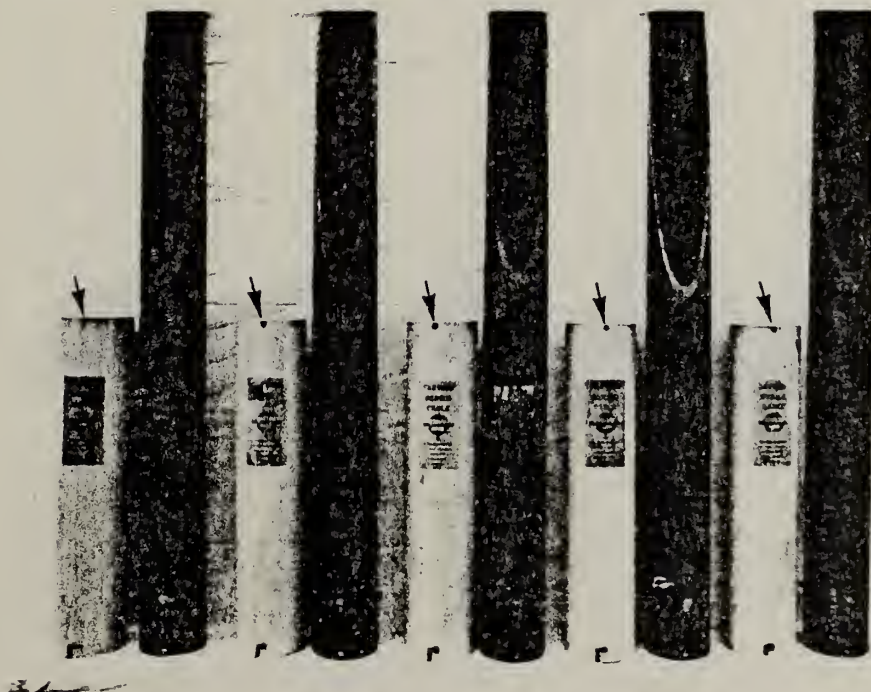
Figure 9. System 5, Sites B,C,G,H, and I, left to right, exposed for six years. Arrows indicate corrosion of the steel rivet on the cover plate cap on all specimens. Streaking of the fiberglass surface on the cover plate of specimens at Sites B,H, and I.

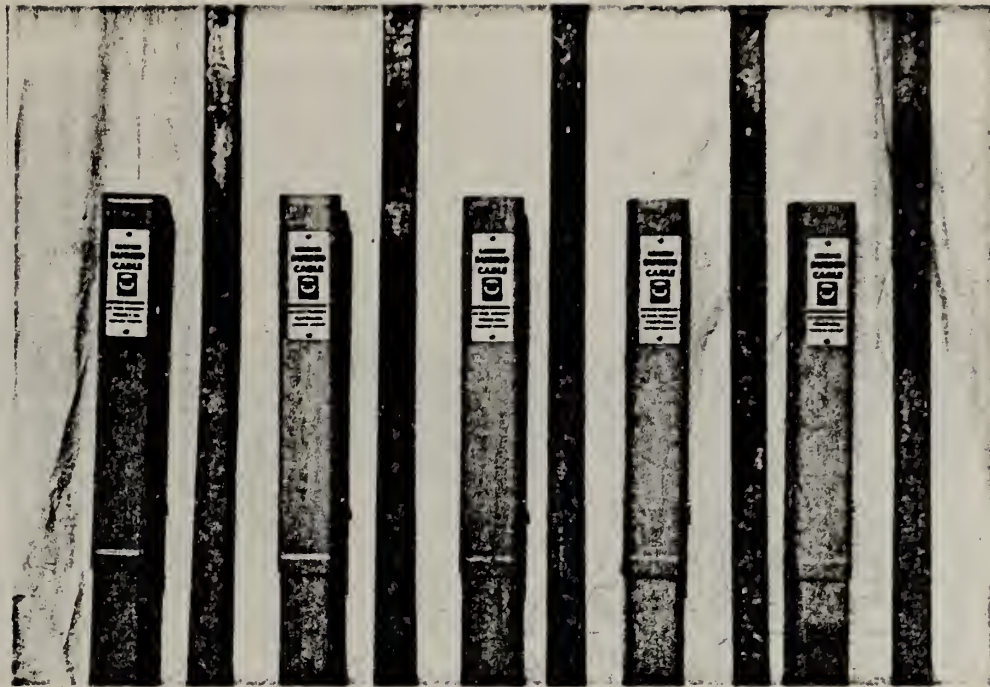
Figure 10. System 6, Sites B,C,G,H, and I, left to right, exposed for four years. Slight to moderate degradation of the fiberglass surface on the cover plate and/or cover plate cap on all specimens. Dark areas indicate corrosion on the mounting stake below ground level on specimens at Sites C and G.

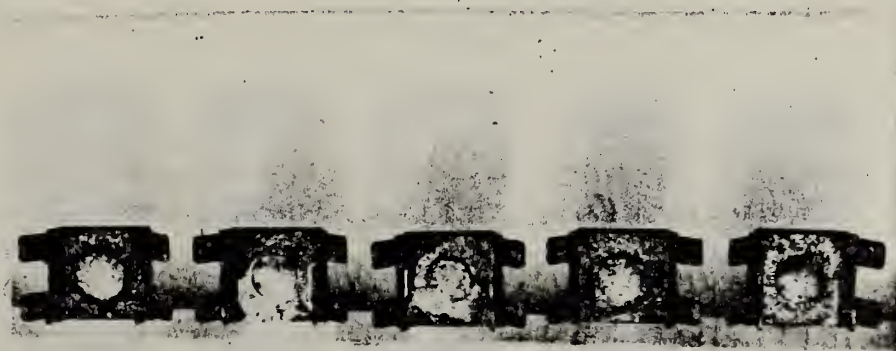
There was little or no corrosion of the pedestal hardware after exposure for one year at Site A, for up to three years at Site B, and for up to six years at Site H. Slight dissipation due to corrosion was noted on the plated brass connector plate on specimens at Sites B, C, G, and I after exposure for six years. The specimens exposed at Sites C and G for six years showed slight pitting on the connector plate to bracket hardware (an aluminum alloy rivet). Slight pitting was observed on the aluminum alloy bracket of specimens at Sites B, C, G, and I after exposure for six years.

Figure 11. Electrical connector plate and securing hardware of specimens from System 1, Sites B,C,G,H, and I, left to right, exposed for six years. Light areas indicate dissipation of the plated brass connector plate at Sites B and I, while the dark areas indicate the same at Sites C,G, and H. Light areas on the securing hardware (an aluminum alloy rivet) indicate slight pitting at Sites C,G, and I.

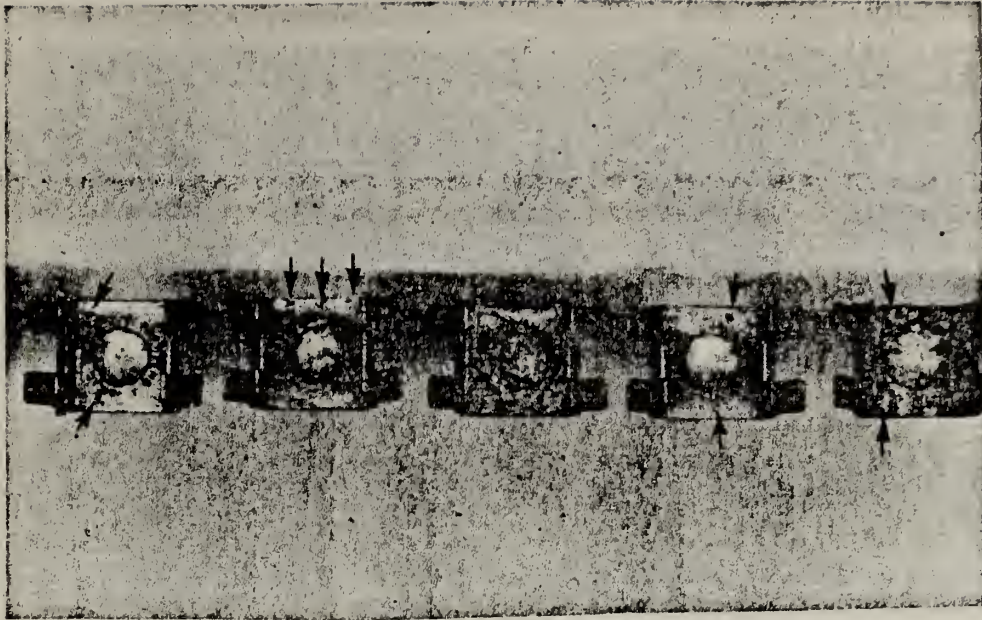
Figure 12. Electrical connector plate and securing hardware of specimens from System 2, Sites B,C,G,H, and I, left to right, exposed for six years. Arrows indicate slight corrosion of the plated brass connectors of specimens. Light areas indicate pitting on the securing hardware (an aluminum alloy rivet) of specimens at Sites C,G, and I.

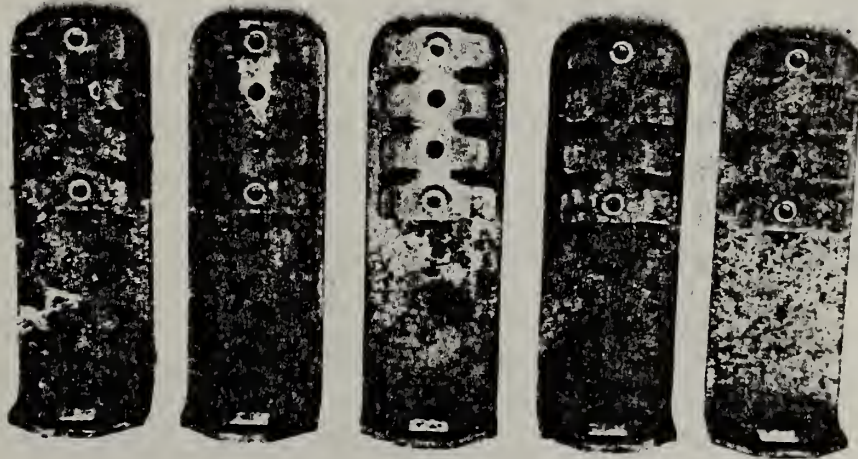
Figure 13. Electrical connector plate, securing hardware, and bracket of specimens from System 3, Sites B,C,G,H, and I, left to right, exposed for six years. Light areas indicate slight attack of the plated brass connector plate on specimens at Sites B,C, H, and I. Dark areas indicate slight corrosion of the plated steel bracket on specimens from Sites B,C,G, and I.

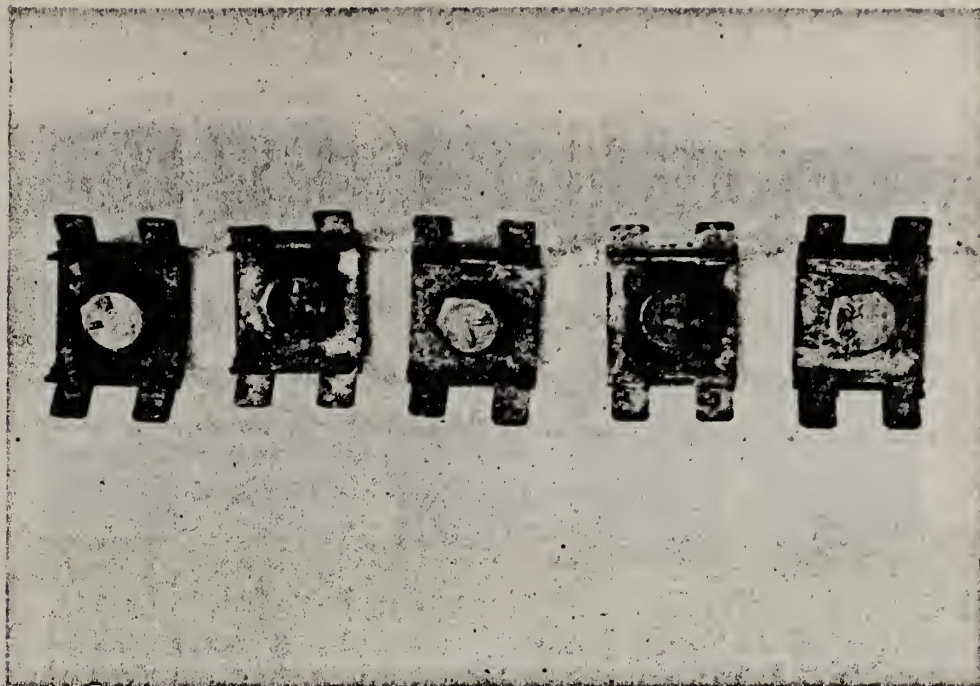
Figure 14. Electrical connector plate and securing hardware of specimens from System 4, Sites B,C,G,H, and I, left to right, exposed for six years. Light areas indicate slight dissipation of the plated brass connector plate on specimens at all sites.

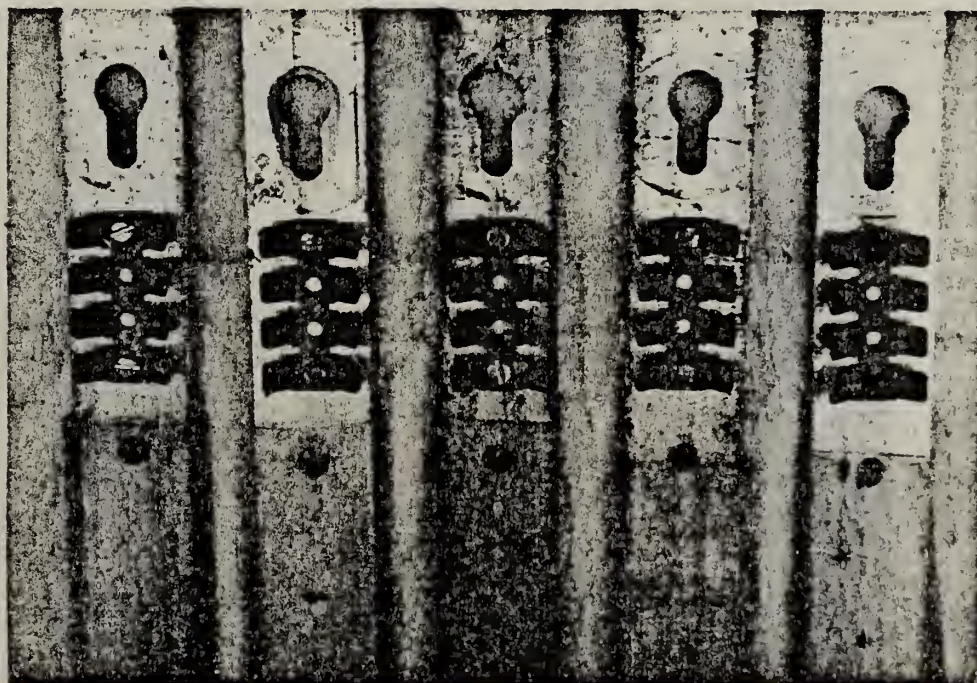
Figure 15. Electrical connector plate, securing hardware, and bracket of specimens from System 5, Sites B,C,G,H, and I, left to right, exposed for six years. Light areas indicate slight corrosion of the plated brass connector plate on specimens at Sites B,C, H, and I. Dark areas indicate slight corrosion of the securing hardware (a plated steel screw) on the specimen from Site B.

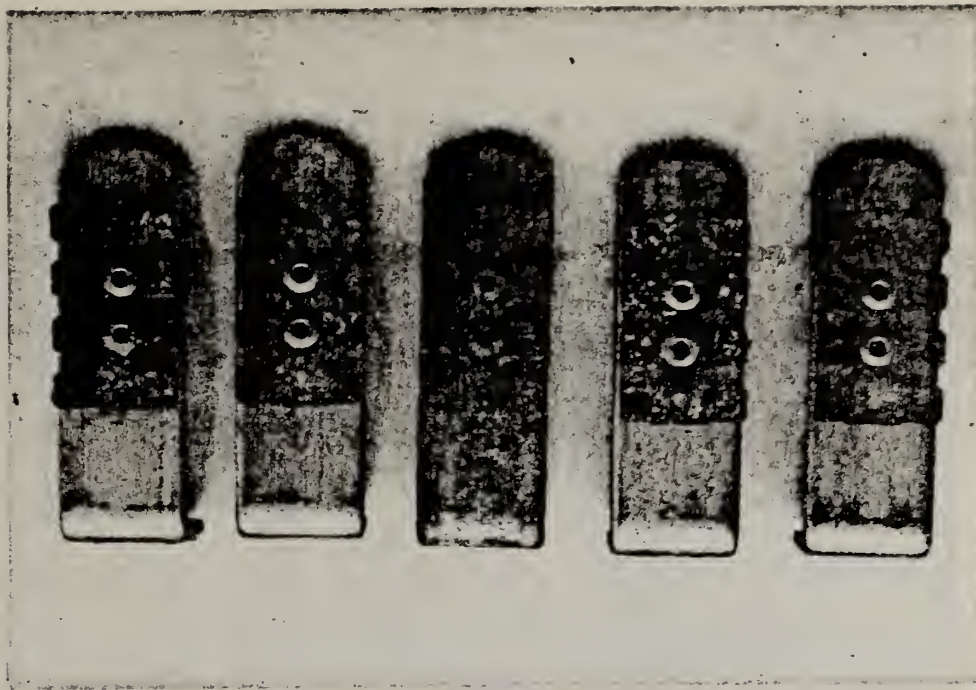
Figure 16. Electrical connector plate, securing hardware, and bracket of specimens from System 6, Sites B,C,G,H, and I, left to right, exposed for four years. Light areas indicate slight attack of the plated brass connector plate on specimens at Sites B,C,H, and I. The light areas on the bracket (an aluminum alloy) indicate pitting on specimens at Sites C,G, and I.

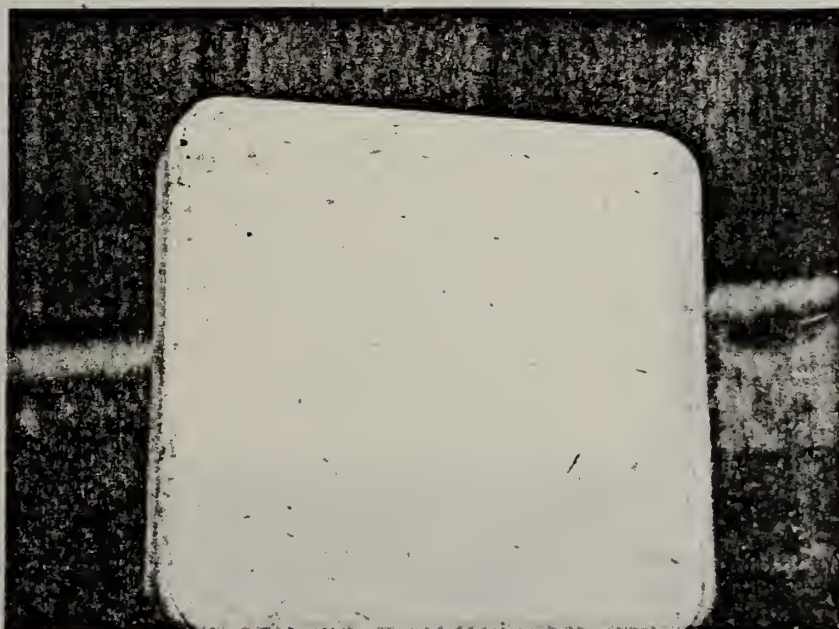
Figure 17. Top view of the cover plate cap of the specimen from System 1 exposed for six years at Site I. Severe degradation of the fiberglass surface. Light areas indicate strands of fiberglass standing out from the resin.

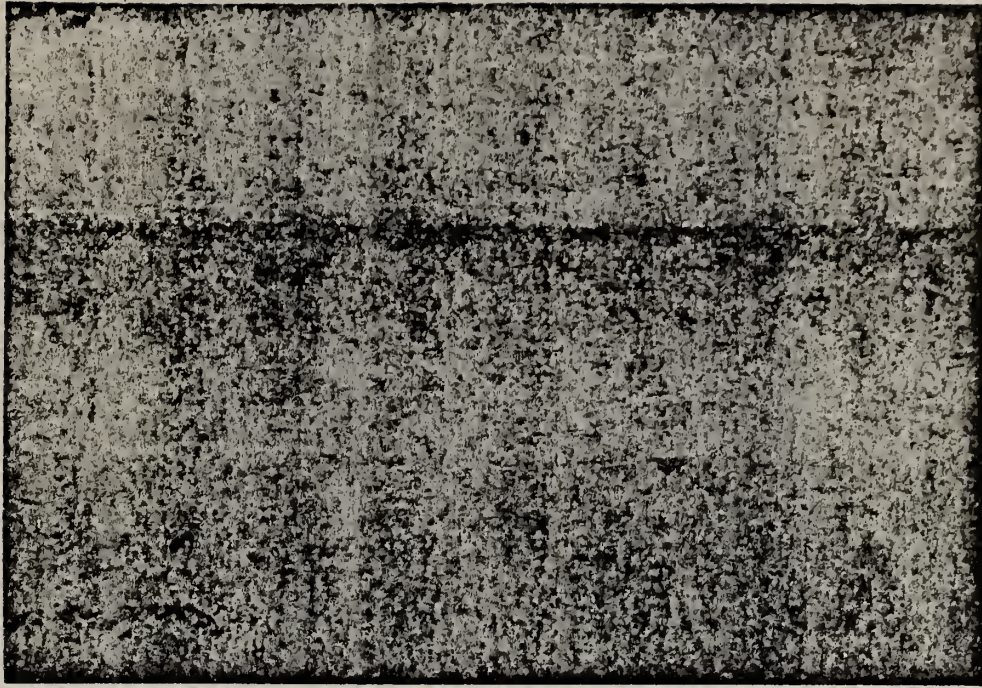
Figure 18. Section of the back plate above ground level of the specimen from System 1 exposed for six years at Site H. Dark lines indicate cracking of the fiberglass surface from 0.060 in. to 0.370 in. in length.

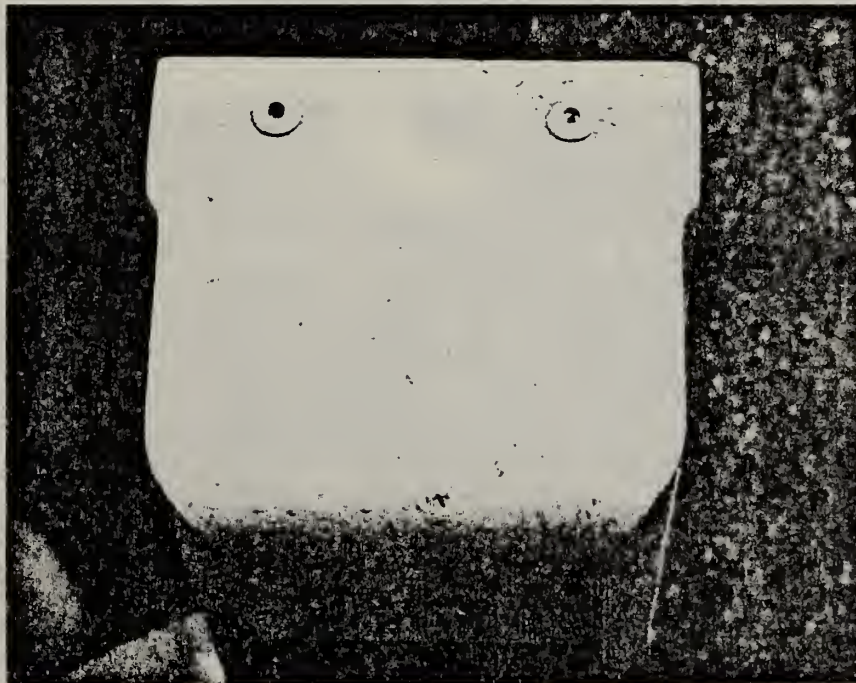
Figure 19. Top view of the cover plate cap of the specimen from System 2 exposed for six years at Site I. Severe degradation of the fiberglass surface. Light areas indicate strands of fiberglass standing out from the resin.

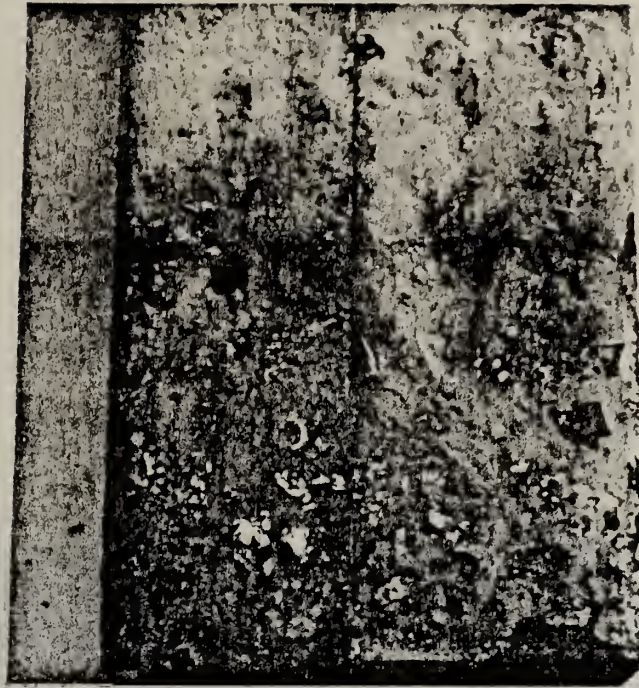
Figure 20. Section of the back plate and ground cover plate below ground level of the specimen from System 3, exposed for six years at Site G. Darker areas indicate severe corrosion due to pitting.

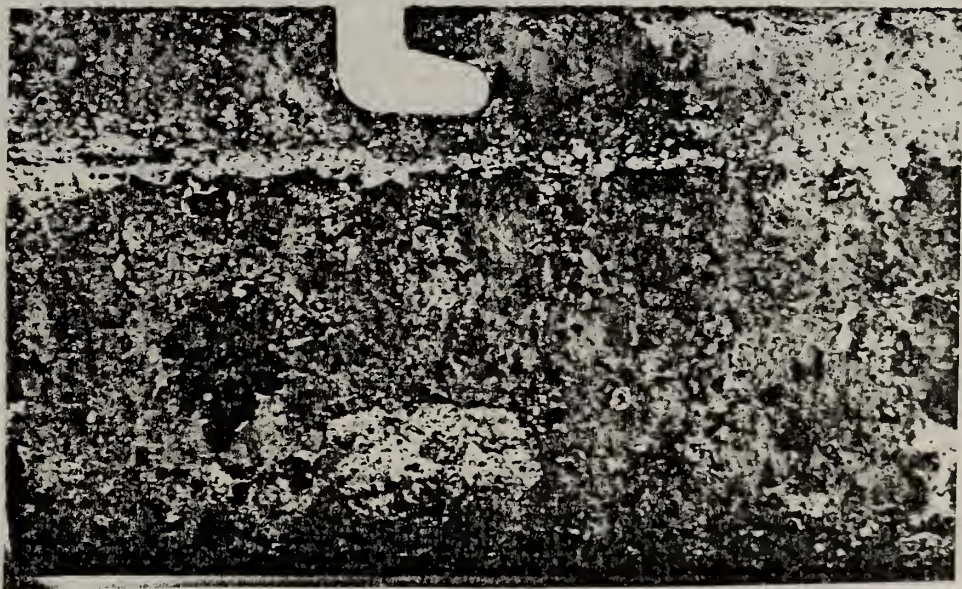
Figure 21. Section of the ground cover plate below ground level of the specimen from System 4, exposed for six years at Site G. Darker areas indicate severe corrosion due to pitting.

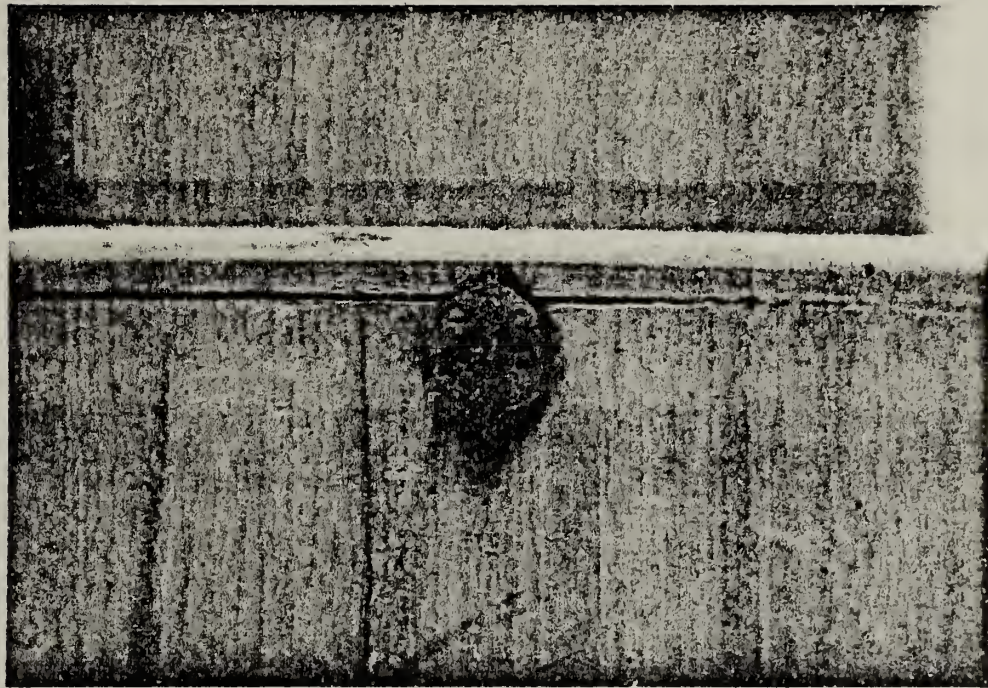
Figure 22. Steel rivet of the cover plate cap of the specimen from System 5 exposed for six years at Site G. Severe corrosion due to pitting can be observed.
